# S/3 Model 15 Project Denmark 2011

In 2010 I had some email exchange with Jørgen Bøgvald of the [Dansk Datahistorisk Forening](#). He told me that the Dannisch Computer Museum has an old IBM Ssystem/3 model 15 in storage. Somewhere in the this email exchange the idea was born to restore the IBM System/3 model 15D to operational status.

After inventory of all equipment and documentation it was clear that everything was there to bring this project to a good end. The project was planned for 5 days in May 2011.

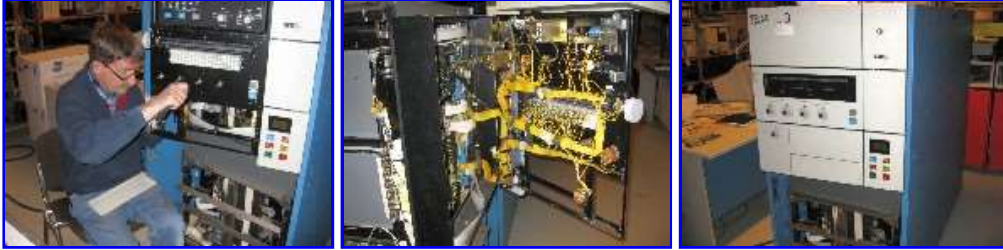
The panel had received a big hit on its left side, even so much that I was unable to turn the display drum freely.

I had taken some spare parts with me to recondition the panel.  
 The left-under section of the panel and the knobs were replaced with better ones.  
 The EPO pull button was temporarily replaced with a long bolt and a washer.  
 After this face lift the CPU looked almost like new again.
